Photographic Evidence

The Following is taken from Appendix B of AD L – Volume 1 for England.

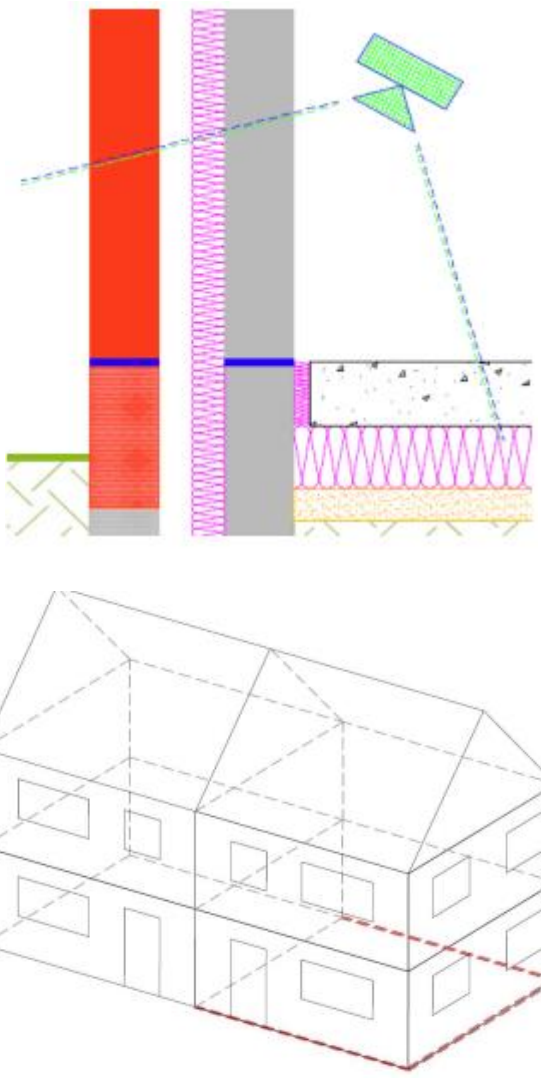
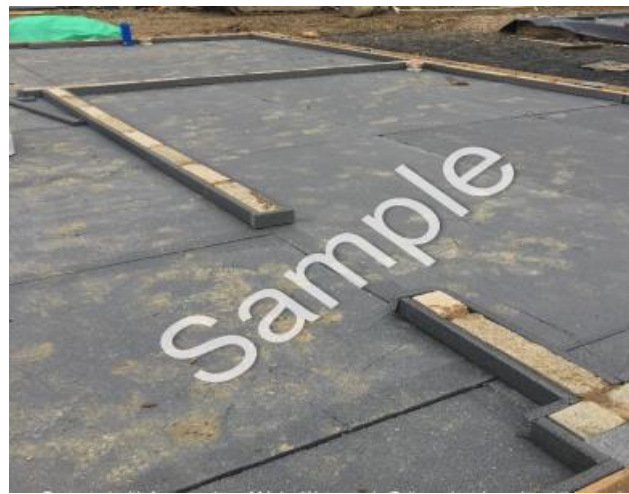
ALL Photo Reference	Direction of Photo	Example	AD L Guidance
<p>1A – GF Perimeter (SAP PSI Ψ Junction REF E5)</p>

<p>Photos should show a continuous strip of insulation in contact with the walls around the perimeter of the ground floor.</p>

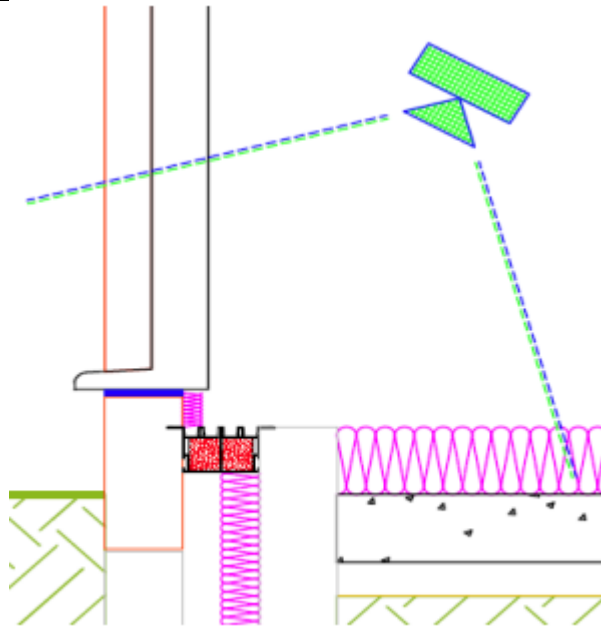
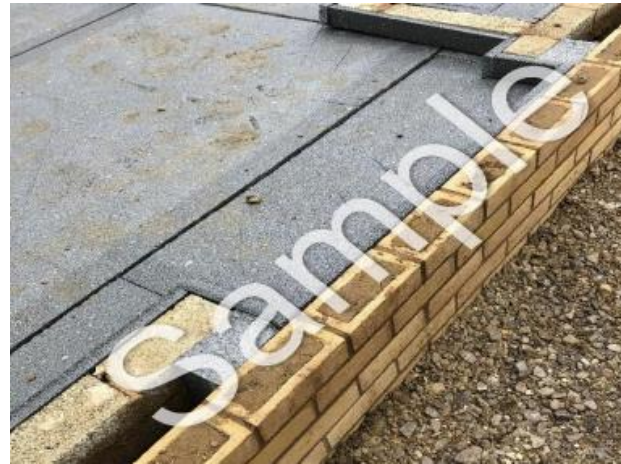
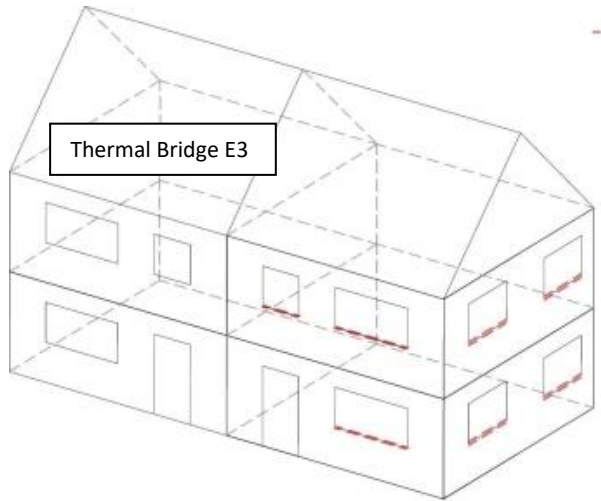
1B – Door Threshold
(SAP Ψ REF
E3)

Photograph should show a strip of insulation or insulated cavity closer in the threshold zone.

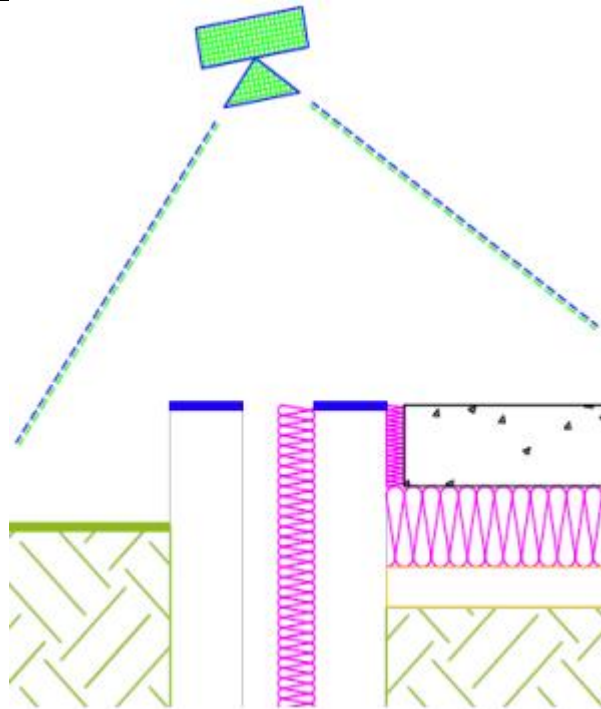
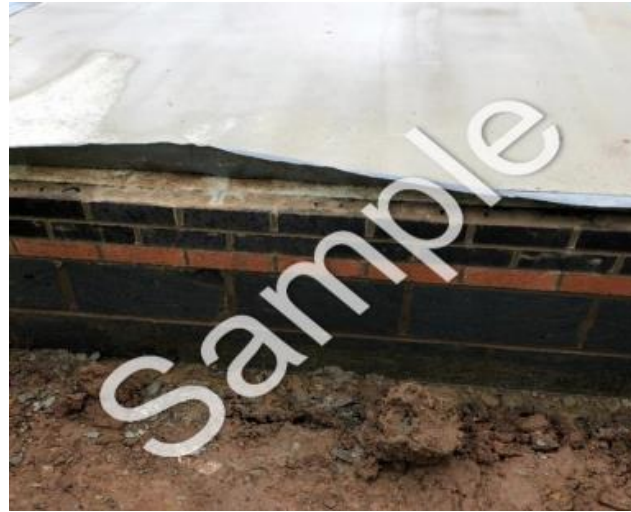
1C – Below
DPC on
External
Walls

Moisture-resistant insulation should be fitted below damp-proof course level and extend to the foundation block/structure.

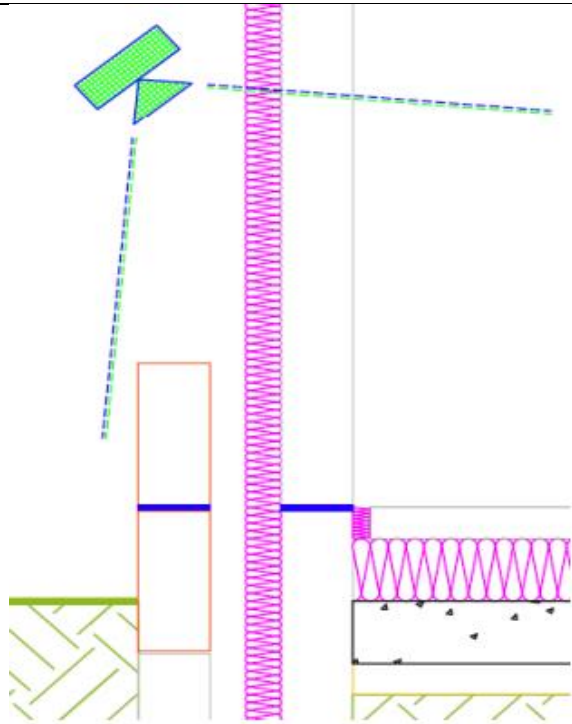
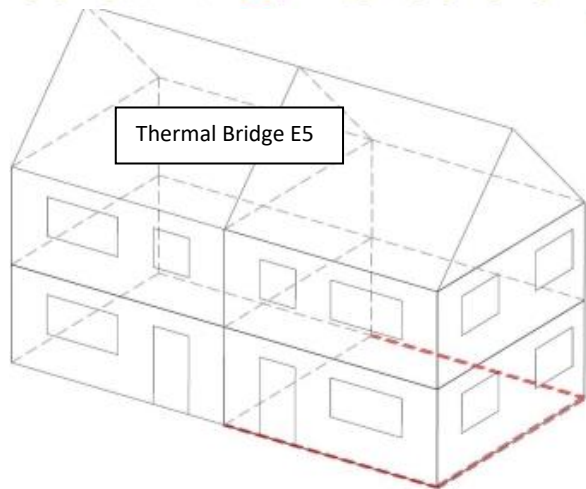
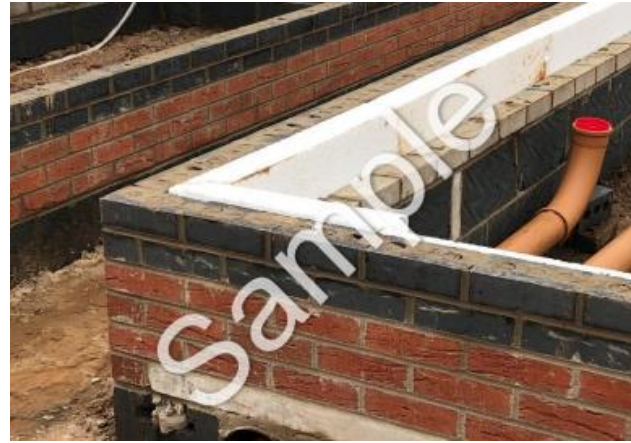
2A-GF to
Ext. wall
junction

(SAP
junction
reference
E5)

External or cavity wall insulation should extend below the damp proof course.

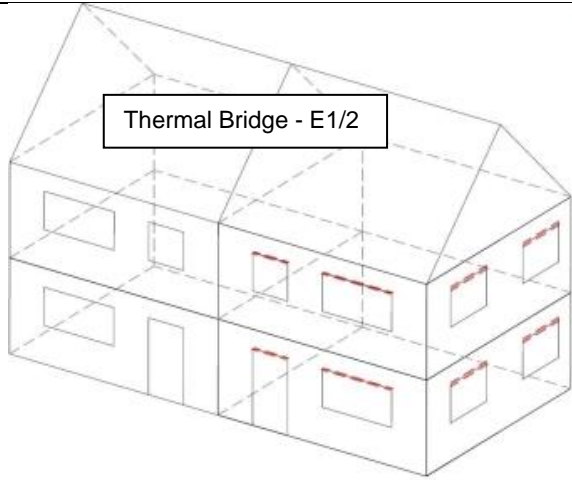
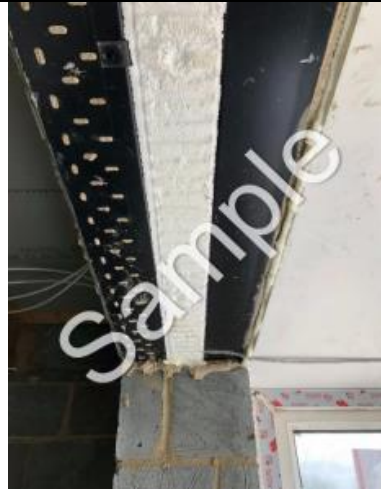
2B –
Structural
penetrating
Elements

(SAP junction
REF E1/2 -
Lintels)

There are a number of items this could cover but discussions with stakeholders suggests this would usually include lintels and photo is required PER OPENING TYPE!

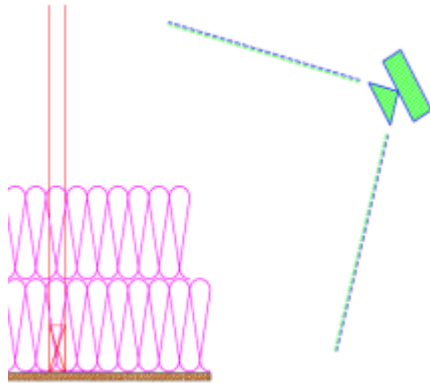
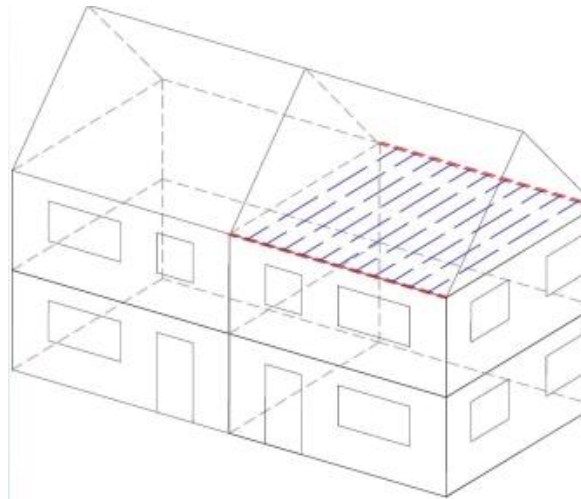
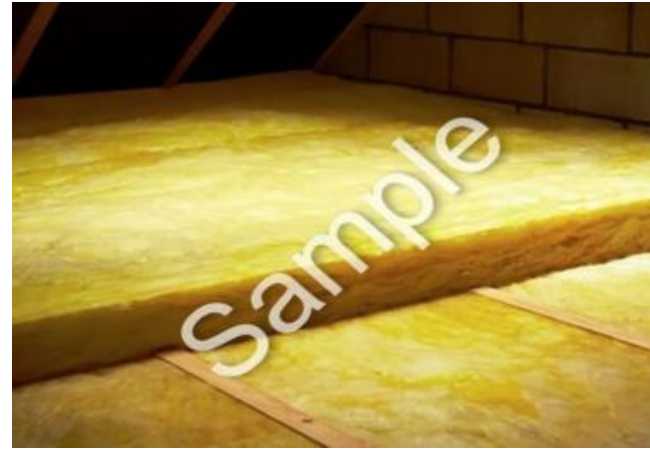
3A – Roof at
joist/rafter
level

Insulation should be installed tight to the structure, without air gaps, and should extend to the wall insulation.

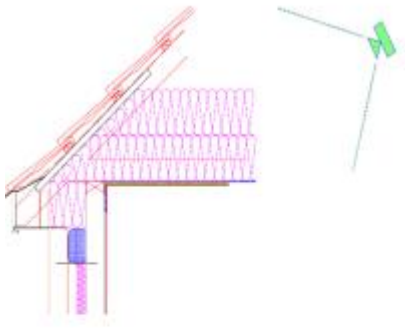
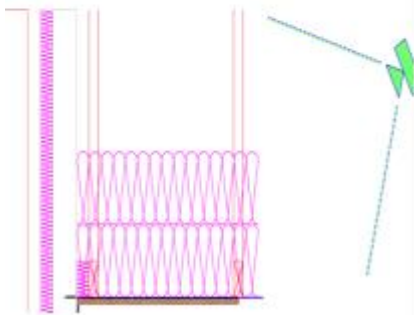
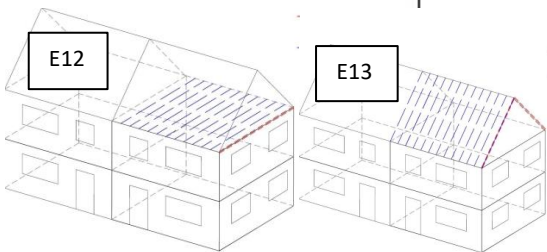
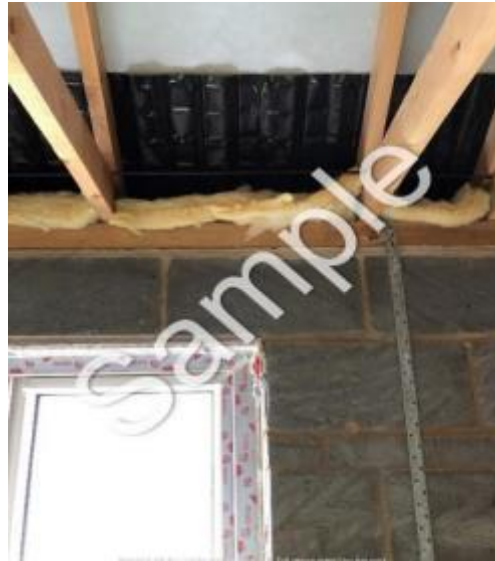
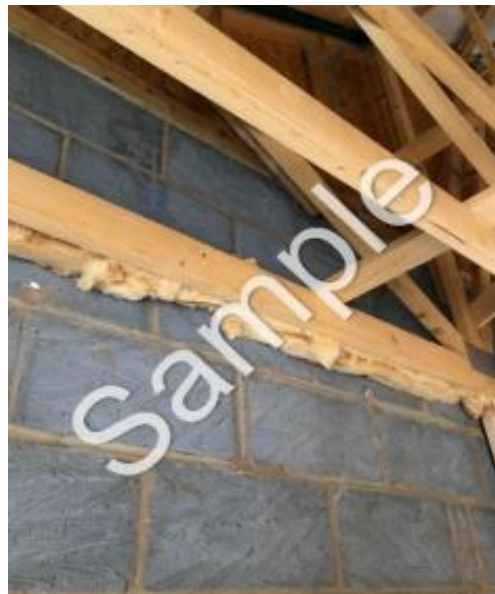
3B Roof at eaves/gables edges

(SAP junction reference E10, E11, E12 and E13)

Eaves photograph should show loft insulation extending beyond the wall insulation to minimise cold bridging.

Gable photograph should show insulation against the inner surface of the external party walls to minimise cold bridging.

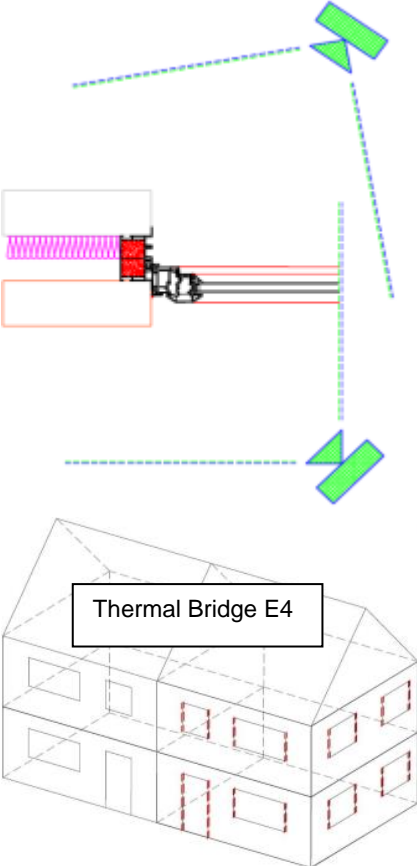
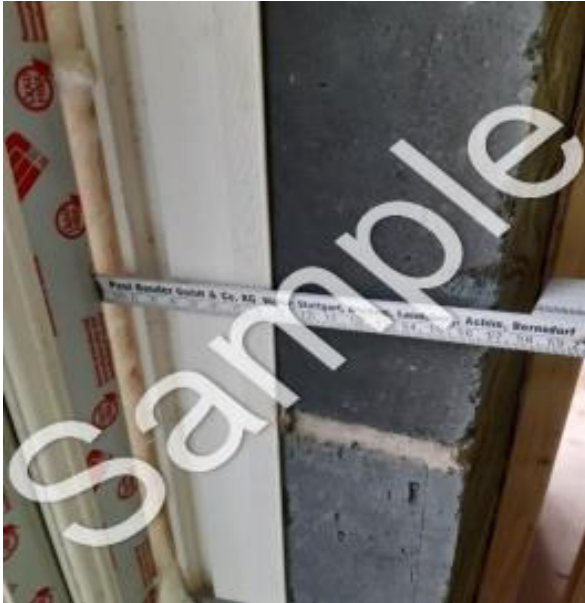
<p>4A/B – Window/door position to cavity closer/insulati on line</p> <p>(SAP junction reference E4)</p>

<p>One photo per window/door type</p> <p>Good practice would be to show a tape measure to check the window/door is in line with the cavity closer/insulation.</p>

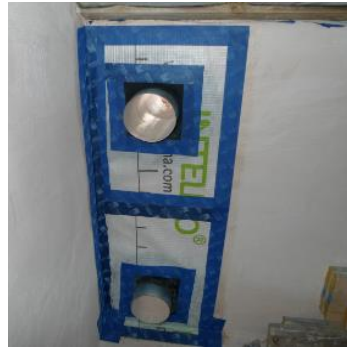
5 Air
Tightness
Issues

This could show how items that penetrate the air barrier, are sealed.

Note: where possible SEES advise to NOT use spray foam, as long term this can compromise and does not provide an air tight seal! For more advice, please contact the office.

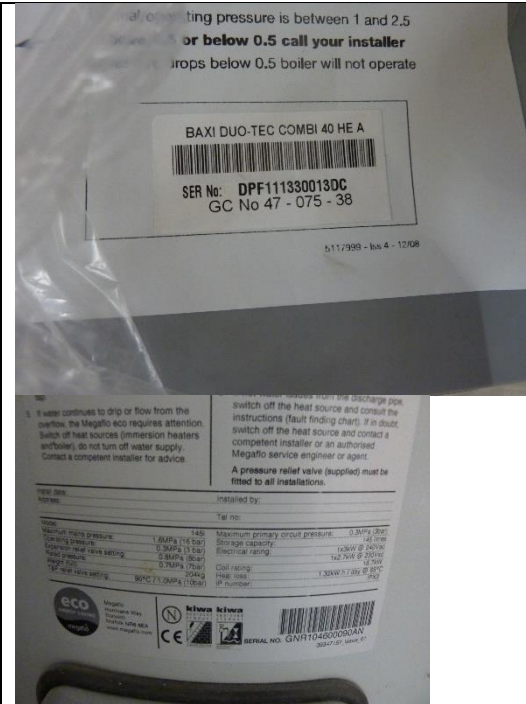
6A –
Plant/Equipm
ent
identification
label(s)
including,
make/model
and serial
number

Please note with Air Source Heat Pumps please provide a photo of the data plate from the external condenser unit.

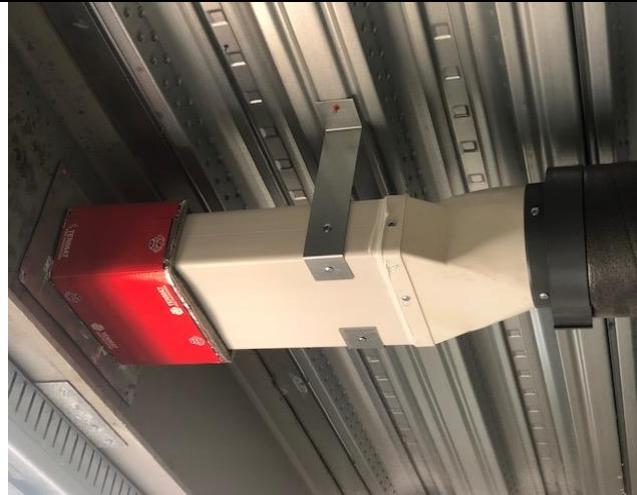
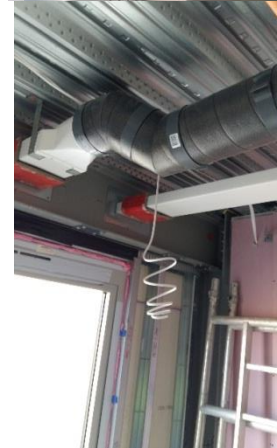
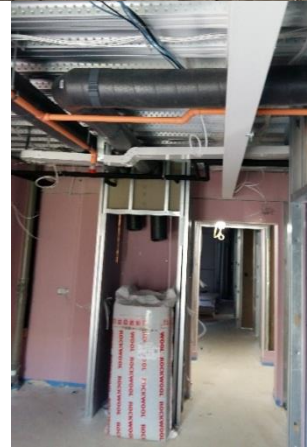
6B Primary pipework insulation

6C Ventilation
Ductwork
insulation
